INDOOR AIR QUALITY ASSESSMENT

**Lunenburg High School
1079 Massachusetts Avenue
Lunenburg, Massachusetts**

Prepared by:
Massachusetts Department of Public Health
Bureau of Environmental Health Assessment
February 2008

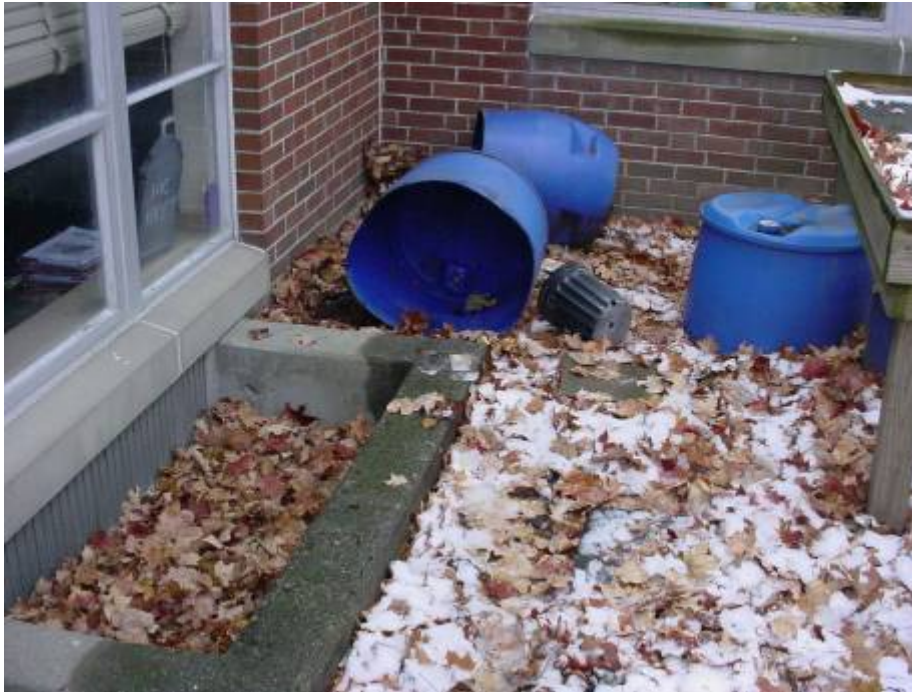
Picture 1

Univent fresh air intakes in several locations (i.e. the enclosed courtyard, outer exterior wall of the building) are located within subterranean, cement-walled pits (Picture 1). An accumulation of leaves and debris was observed below a number of these fresh air intakes. Wet leaves can provide a source for mold growth and odors that can be entrained into the building by the air handling equipment.

Cement Lined Pit Containing Univent Fresh Air Intake

3. Remove leaves and other debris from univent fresh air intake subterranean pits, clean and inspect periodically.
4. Ensure classroom doors are closed to maximize air exchange.

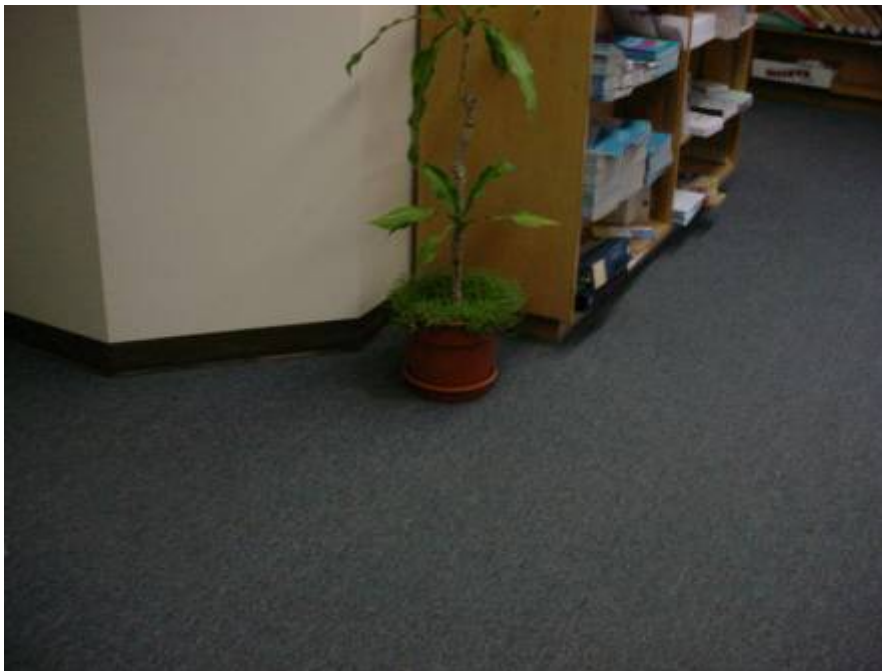
Picture 2

Plants were noted throughout the school. A number of classrooms have water damaged windowsills that appear to have resulted from over watering of plants . In several rooms, large plants are located on wall-to-wall carpeting (Picture 2). Plants should be properly maintained and equipped with drip pans. Plants should be located away from ventilation sources (e.g., air intakes, univent diffusers) to prevent the entrainment and/or aerosolization of dirt, pollen or mold.

Plant On Carpet

11. Relocate compost pile from inner courtyard.
12. Remove plants from floor with wall-to-wall carpeting. Consider reducing the number of plants.
13. Cut shrubbery in a manner to maintain a space of 3 feet from univent fresh air intakes.

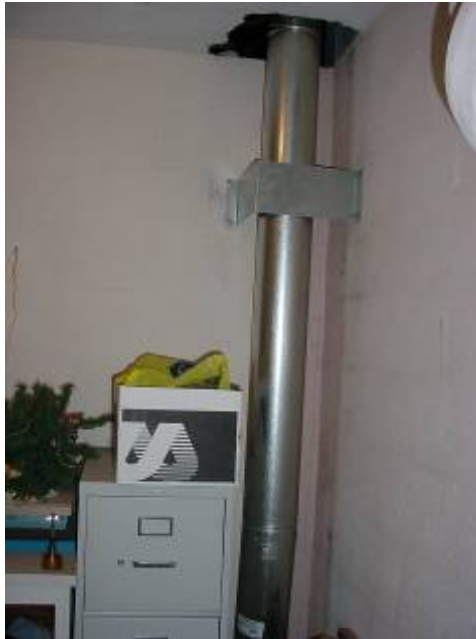
Picture 3

A number of other conditions that can affect indoor air quality were noted during the assessment. An odor was detected in Room 222. This odor was traced to a storage closet, containing ductwork from the water heater (Picture 3), which is located in the crawlspace below room 222. The seams to the exhaust ductwork were not sealed with mastic. When the exhaust system for the water heater is activated, combustion products are driven up the ductwork. As a result, the vent becomes pressurized. Therefore, if any unsealed holes or seams exist in the ductwork, the combustion products from the gas-fired water heater can escape from the ductwork. No measurable levels of carbon monoxide were detected in Room 222 or its closet during this assessment.

Ductwork In Closet, Room 222

1. The jerry-rigged drain system for the broken PVC telephone wire should be rendered air tight and all seams in the sewage ejector system should be sealed. The exhaust fan in the room should be operating during school operating hours at minimum.
2. Seal all the seams and holes in all ductwork in the room 222 closet with an appropriate sealing compound. Spaces between the floor and duct should also be sealed. Consider consulting a ventilation engineer to identify the metal fume source in the water heater. Consideration should be give to relocating the exhaust vent motor to the roof so that the water heater exhaust vent is internally depressurized.

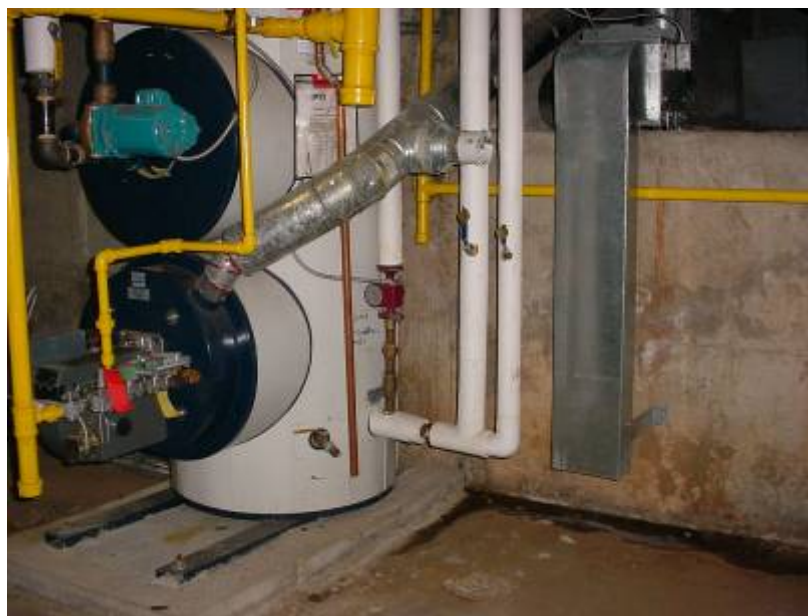
Picture 4

BEH staff examined the hot water heater (Picture 4) and detected a noticeable metallic taste when in close proximity to the water heater, while the exhaust system was deactivated. Metallic tastes are an unusual occurrence; this may indicate a malfunction in the water heater that is producing metal fume during its operation. Metal fumes may also enter Room 222 via holes or seams in the ductwork or migration the spaces between the ducts and the floor in the closet. Products of combustion and metal fumes can be sources of eye, nose and throat irritation.

Water Heater

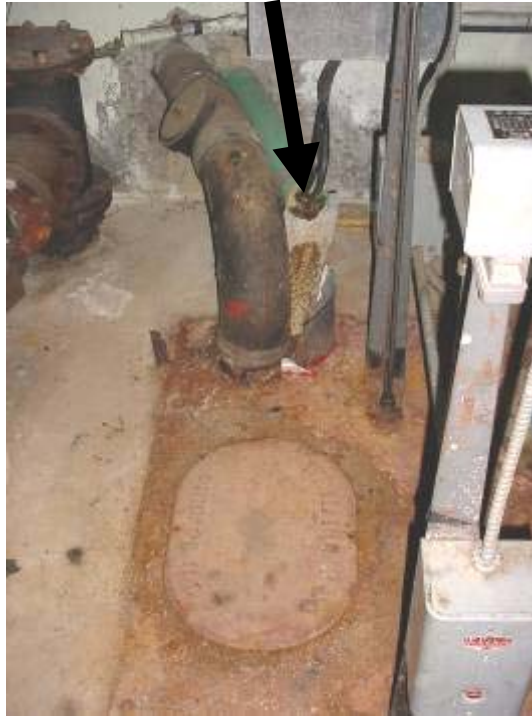
Picture 5

A strong sewage odor was observed in the area where the sewage ejector pumps are located. As reported by Mr. Londa, a backhoe breached a PVC pipe that encloses the telephone lines located outside the building. The breach resulted in water penetration to the sewage ejector room (Picture 5). In order for water to drain from this room, a jerry-rigged drain system was installed in the sewage collect tank, thereby allowing odors to escape from the sewage ejector system. In this condition, groundwater and odors from the broken pipe and the sewage ejector system could all be sources of odor in this room. An exhaust fan was installed in this room, but it was deactivated at the time of the assessment.

Telephone Conduit Leaking Water In Sewage Ejector Room

1. Examine the feasibility of replacing damaged gymnasium block windows.
2. Repair the broken PVC telephone conduit.

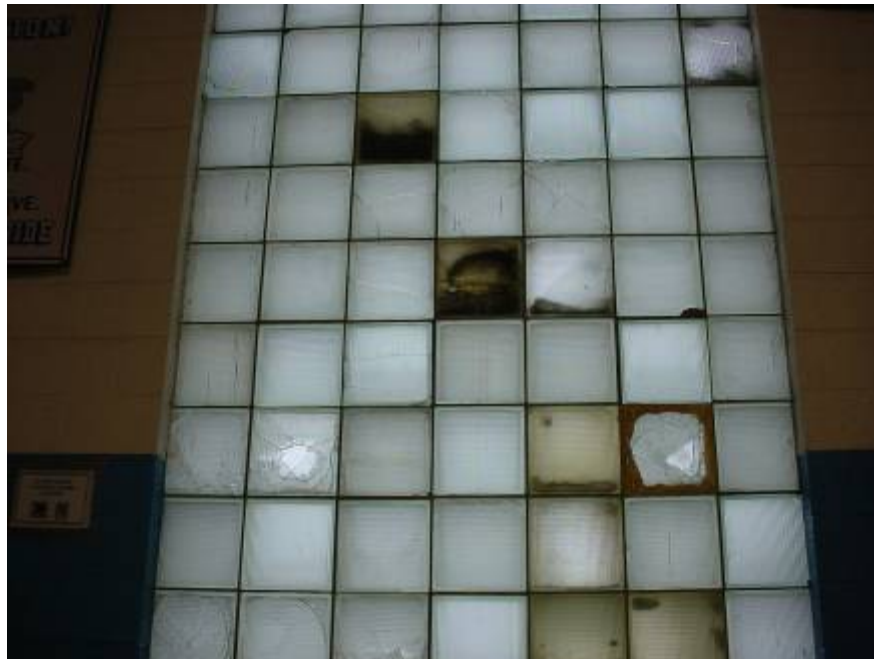
Picture 6

The gymnasium had cracked block windows, as originally noted in the BEH assessment of 2001 (Picture 6). Glass window blocks were heavily damaged by vandalism in many classrooms. Exterior surfaces of glass blocks are either broken or cracked. Several glass blocks were broken in a manner to allow for water to accumulate within the block, creating an "aquarium-like" appearance.. Damage to blocks can lead to water penetration through masonry and serve as a potential microbial growth source. Moistened cardboard can be a mold growth medium. Standing water in these blocks can stagnate leading to bacterial growth, mold growth and possible nuisance odors.

Damaged Glass Block, Gymnasium
